RE: County of Riverside – Riverside University Health System
Behavioral Health Franklin Repurposing Project
Assessment of Existing Building Condition
3021 Franklin Avenue, Riverside CA 92507

3021 Franklin Ave
MEP Building Assessment
7/6/2021

RE: 3021 Franklin St.
Riverside, CA 92507
ISE Project No.: 21-7215

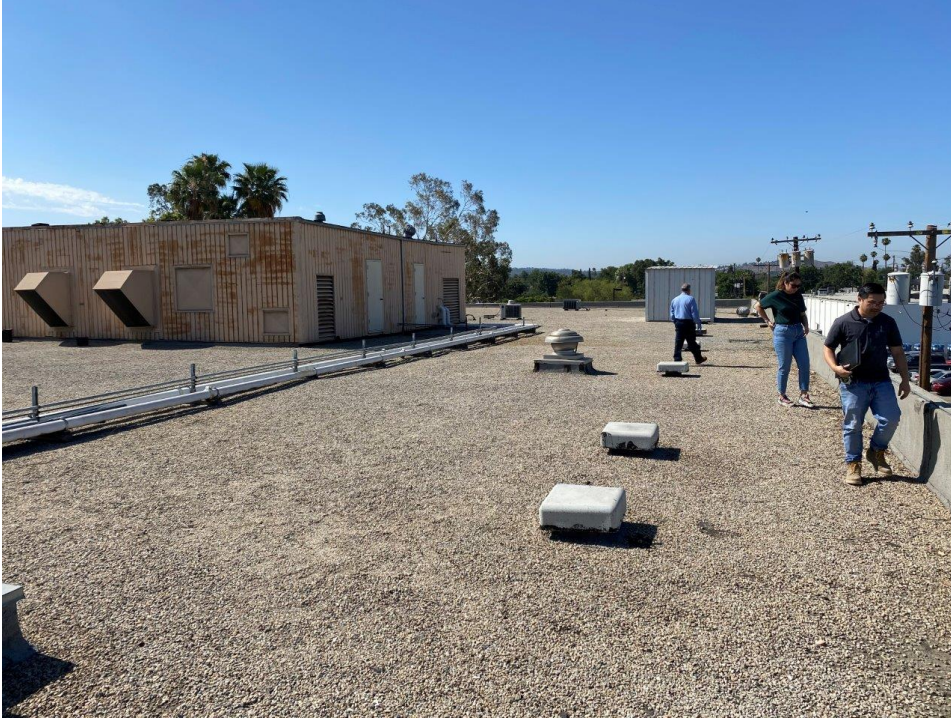
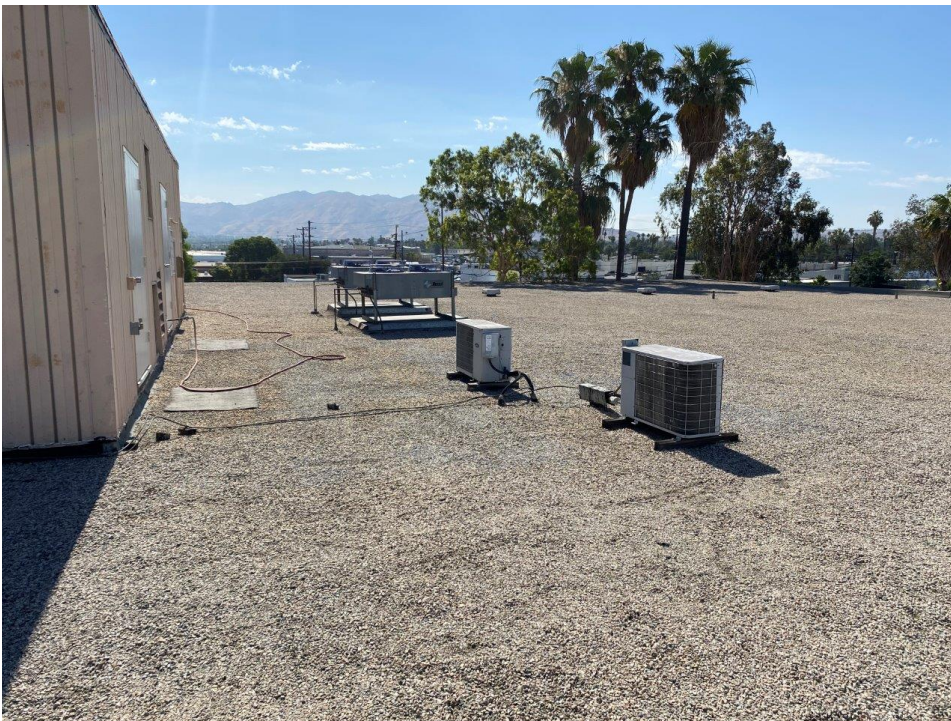
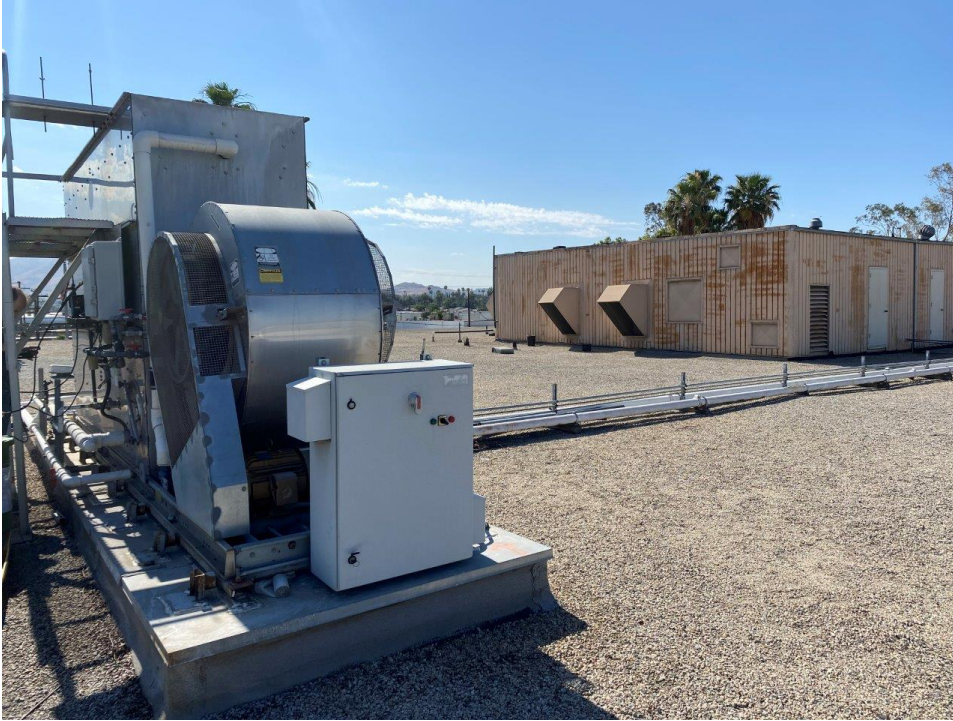
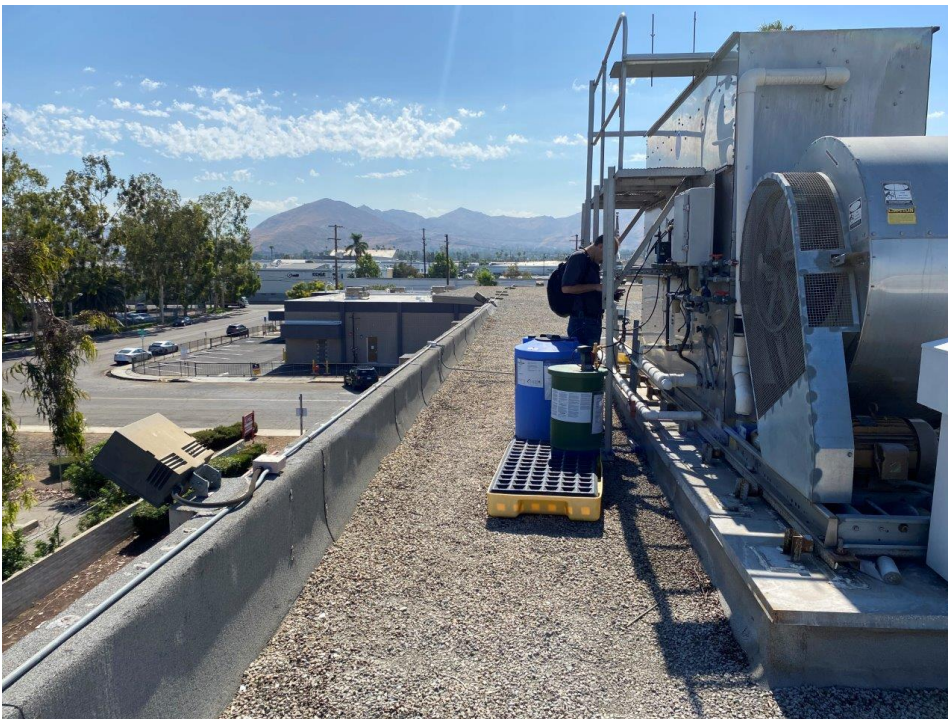
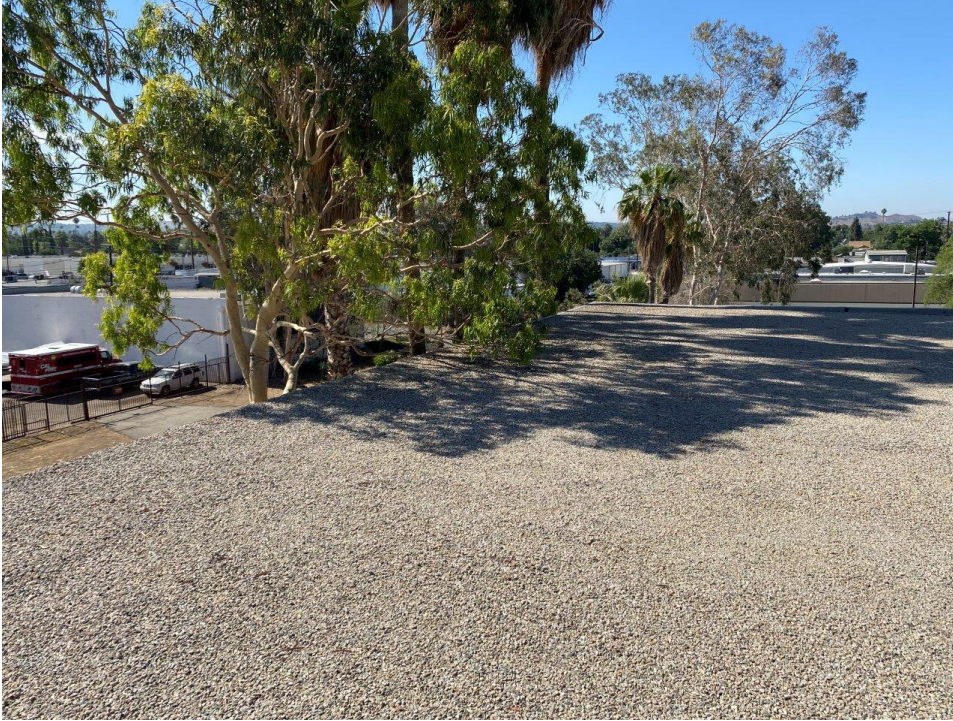
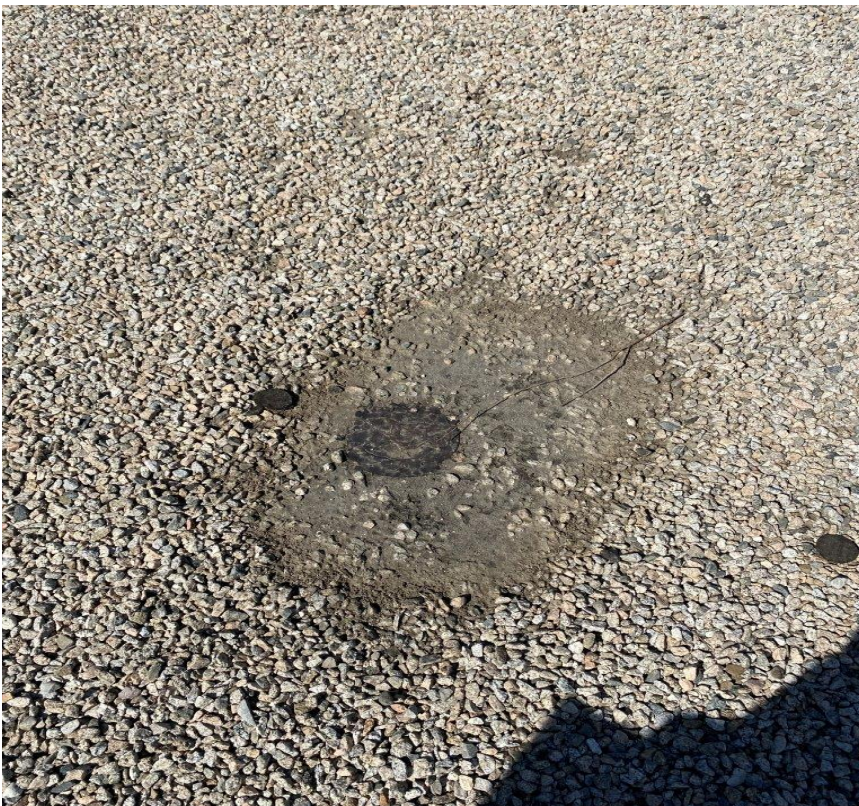
- Smoke Control – Both floors will be required to have a smoke control system due to the change in occupancy classification.
- Roof – The roof consists of an asphalt built-up roofing system with a gravel ballast. Although the roof is not in terrible condition it is most likely the original roof and therefore past its reliable lifespan. No significant signs of roof leaking is observable. Recommend replacement with a new single liner such as PVC or TPO. (see attached photos #1-6)

Photo #1 Existing Roof

Photo #2 Existing Roof

Photo #3 Existing Roof

Photo #4 Existing Roof

Photo #5 Existing Roof

Photo #6 – Old Roof Repair

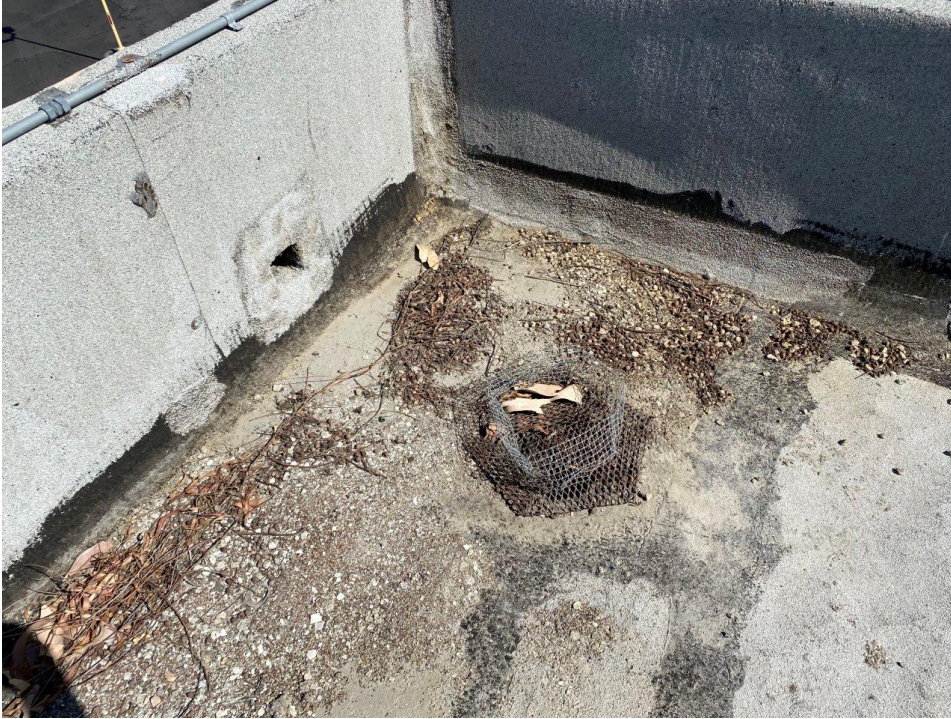
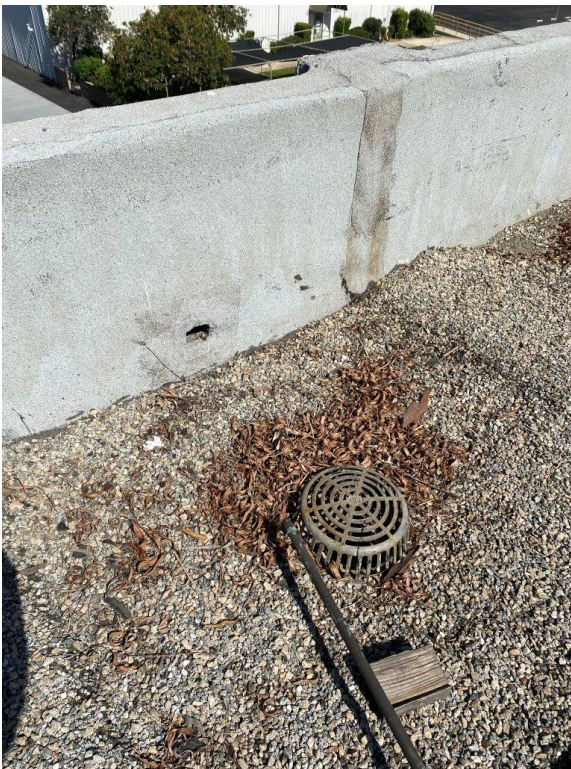
- The existing roof drains and overflow drains are in poor condition and of poor design. The existing overflow system consists of a small hole thru the parapet approximately 8" higher than the roof drains. If the roof drains were to be blocked too much water would build up before the overflow drains will function. Recommend replacing drains with a rooftop drain and overflow system. (See photos #7 & 8)

Photo #7 Roof Drain – Note the overflow and screen.

Photo #8 Roof Drain – Note the overflow.

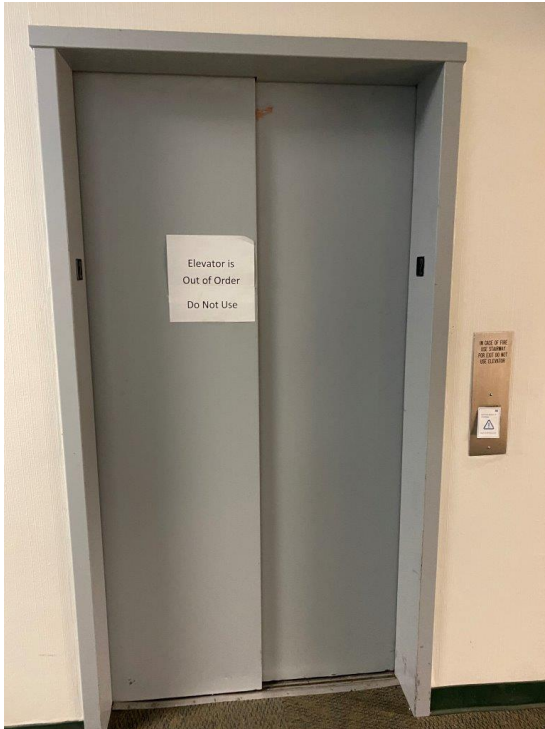
Photo #9 Elevator not functioning.

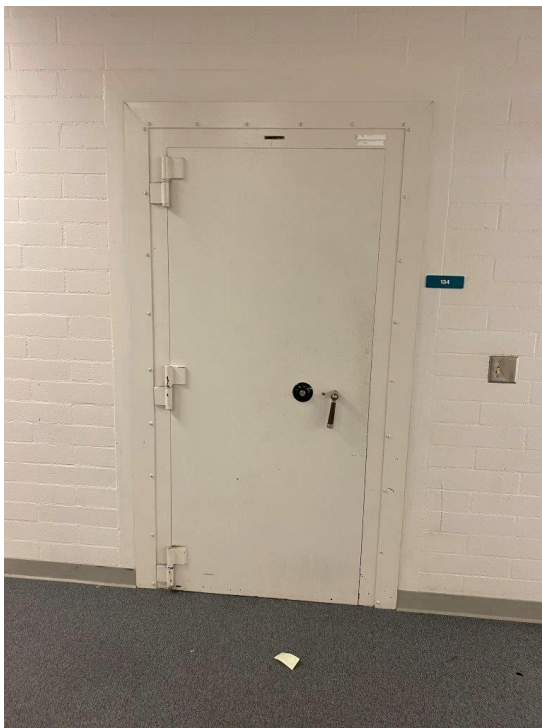
Photo #10 Bank Vault Door

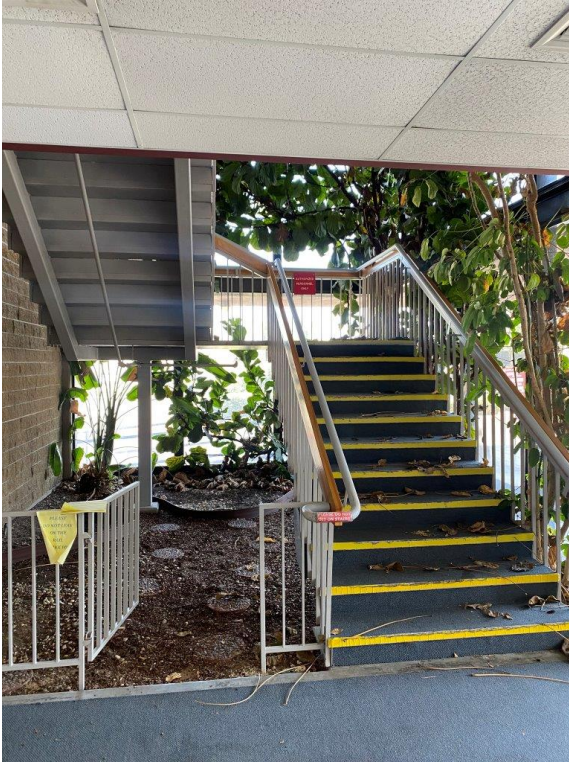
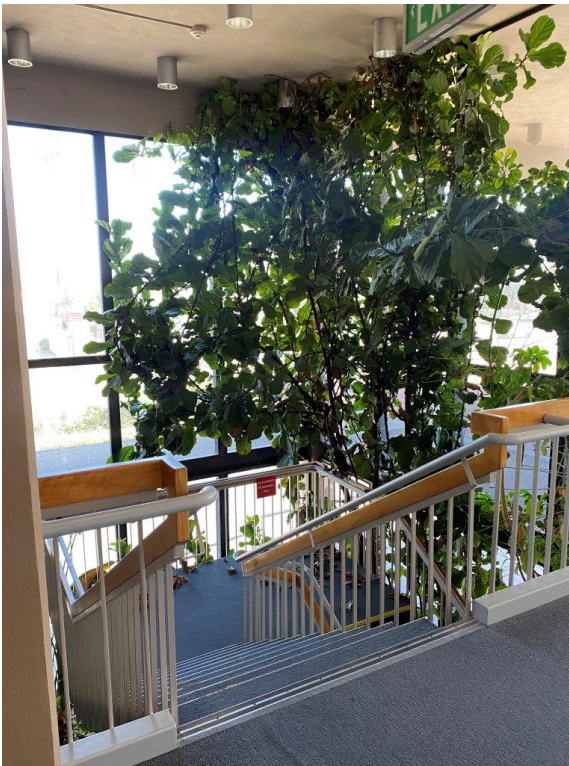
- ADA for both stairways – Both stairways and handrails will need to be updated to meet current accessibility codes. (See photo #11 & 12)

Photo #11 Atrium Stairs

Photo #12 Atrium Stairs

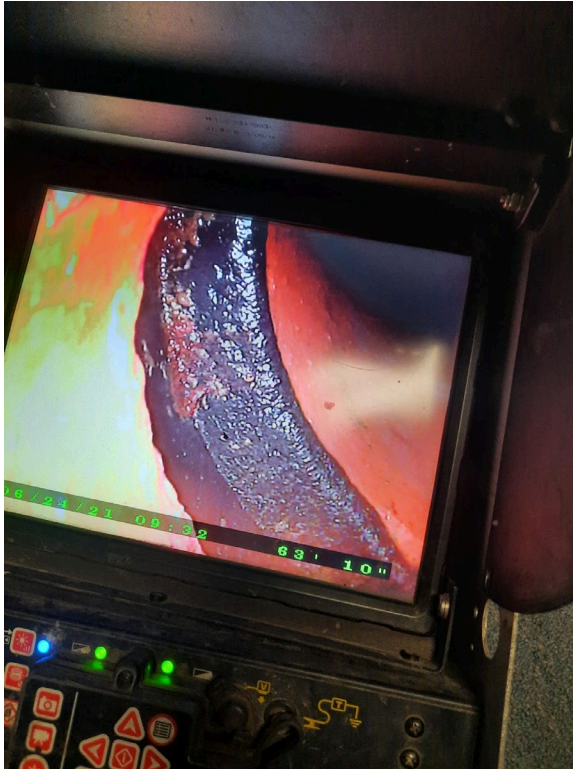
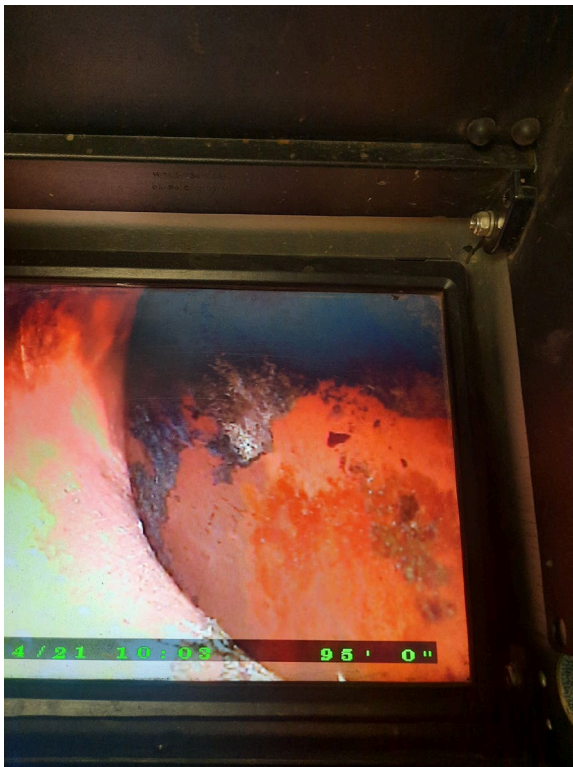
- Recommend the installation of a new liner from restroom to outside of the building.
- Observed Clay sewer pipe where the sewer exits the building. The clay pipe has settled to the point that every clay joint has a lip on it to catch debris coming down the line.

Photo #13 Clay pipe interior. Note separation at joint.

Photo #14 Clay pipe interior.

- Recommend that all of the 6" clay be descaled, and a new liner installed. New clean outs should be reinstalled.
- Observed that the water supply system is a mixture of copper and galvanized, mostly galvanized. All the galvanized piping is in poor condition with evidence of many repairs over the years.

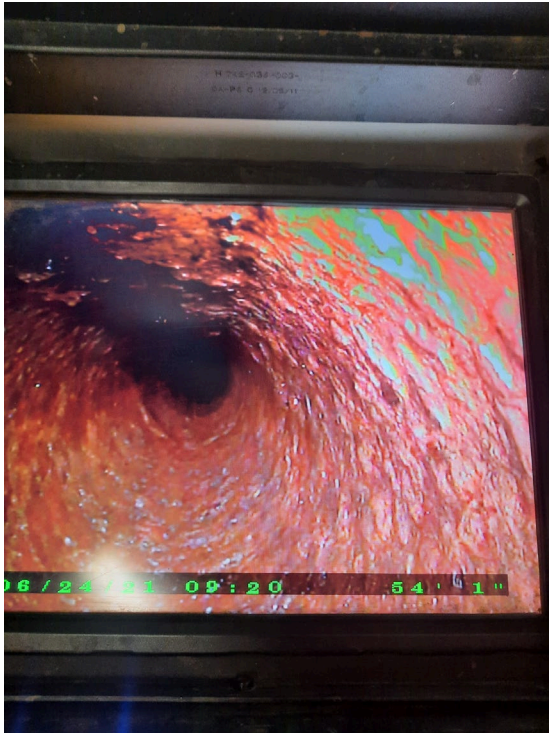
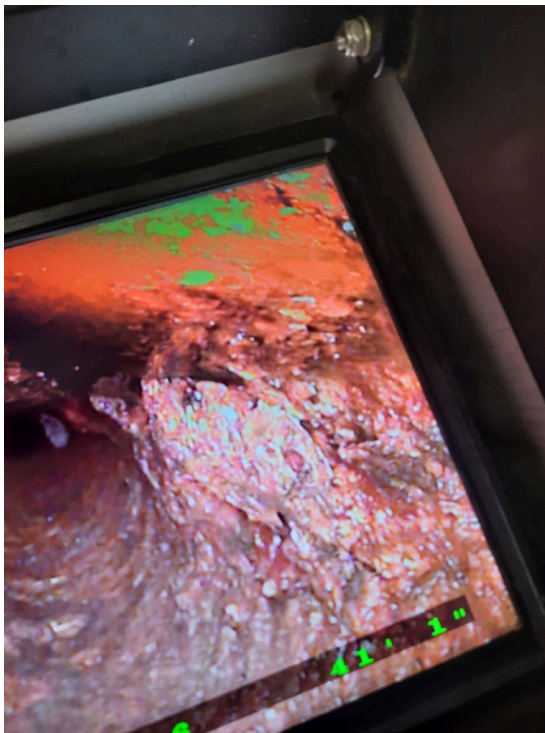
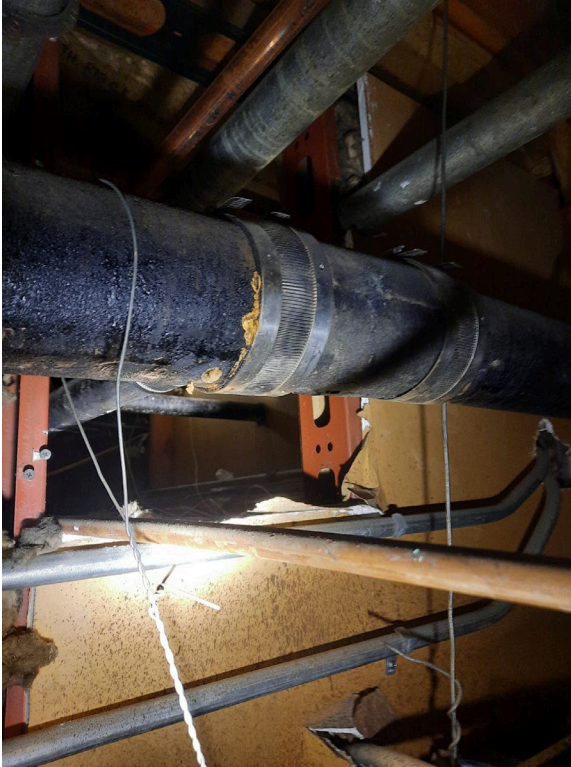
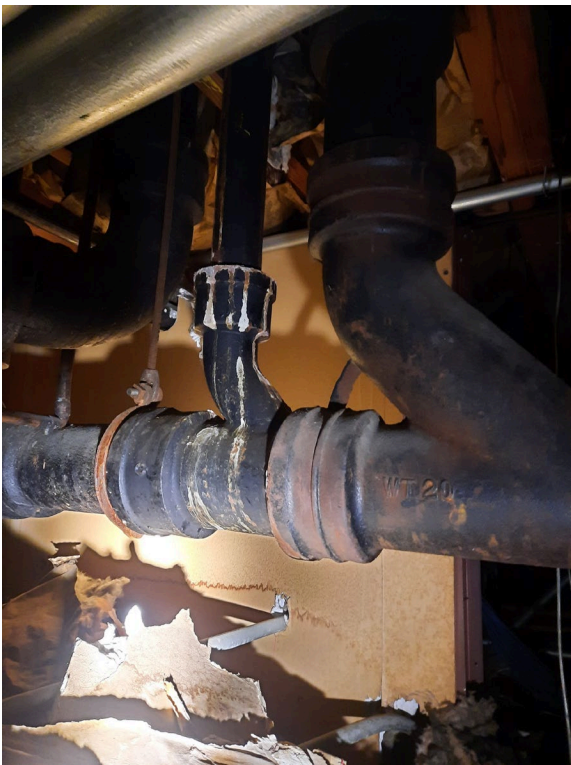
- Observed sewer piping run with camera from furthest point of sewer starting at unisex restroom on first floor through clean out on wall. Sewer pipe is old cast iron with a lot of calcium build up and rust. This may catch toilet paper and cause stoppage in the future. (See photo #13-21)

Photo #15 Cast iron pipe interior. Note rust and scale.

Photo #16 Cast iron pipe interior. Note rust and scale.

Photo #17 Cast iron pipe with minor corrosion at joint.

Photo #18 Cast iron pipe with some corrosion at joint.

- Recommend descaling sewer line and shooting a new liner from restroom to restroom in the middle of the building where back-to-back restrooms are.
 - Recommend saw cutting floor in main restroom to replace all toilet drops and sink drops and connect into section of new 4" ABS that would be installed between shots of liner.

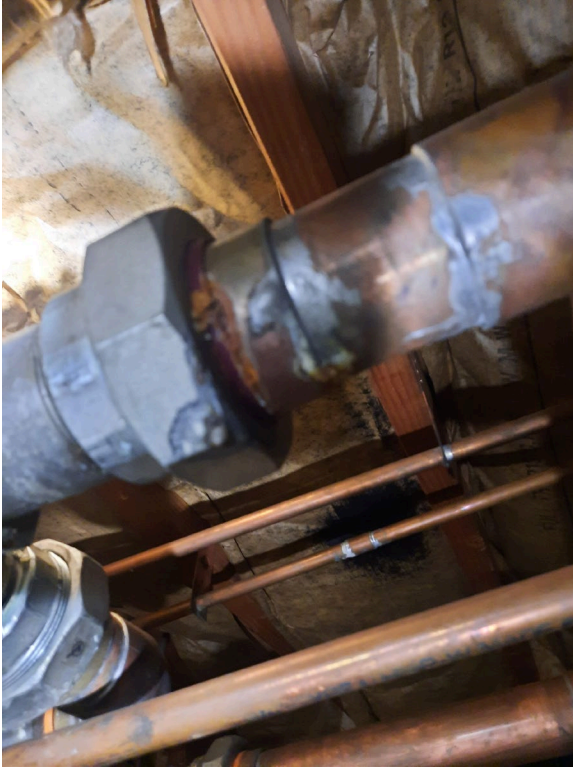
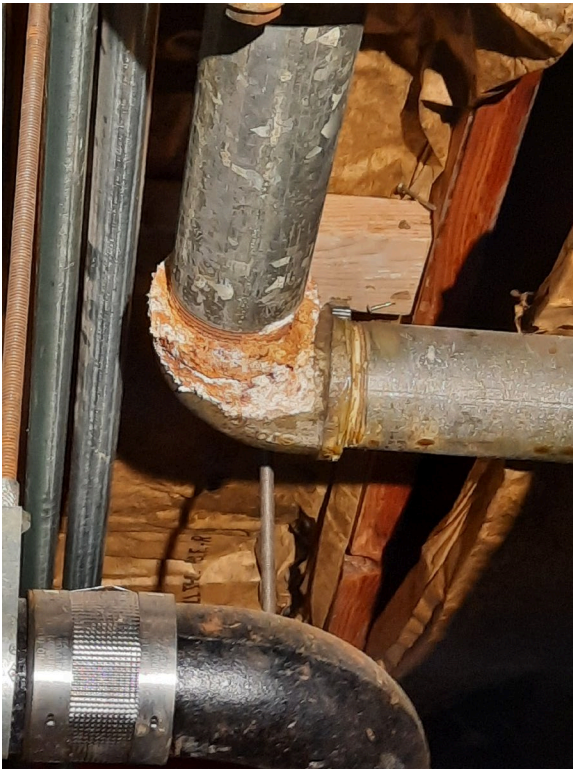
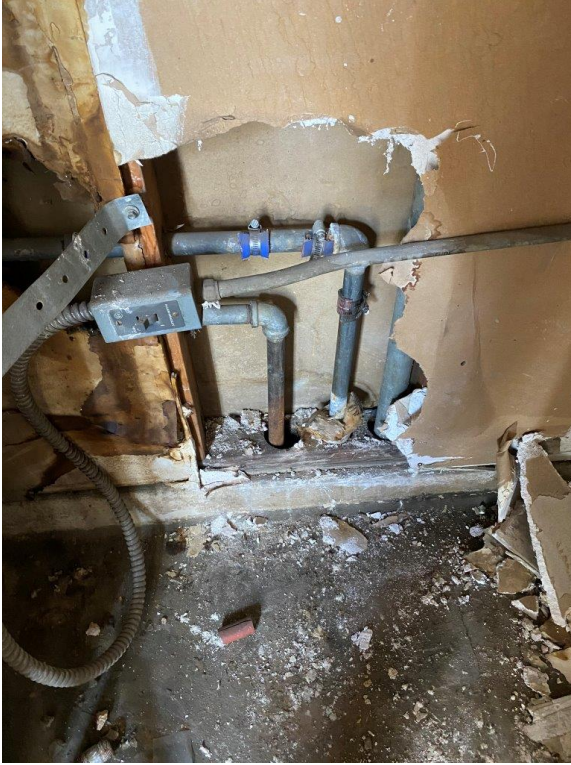
Photo #19 Old repair joint between original galvanized pipe and newer copper pipe

Photo #20 Old galvanized pipe showing corrosion.

Photo #21 Galvanized pipe in mechanical penthouse note the temporary repairs with rubber hose and hose clamps.

The building is supplied with 2-1/2" domestic cold water line that is copper on the exterior of the building and the interior of the building is a mixture of copper and galvanized steel. Majority of the interior of the building is galvanized steel piping which is in poor condition and is showing signs of leaks and major repairs over the years.

- Recommend replacing all domestic water lines from the incoming 2 ½" copper mainline through the exterior wall and into drop ceiling inside of the building.

All existing galvanized cold water piping within the building should be replaced with a more durable piping material such as copper.

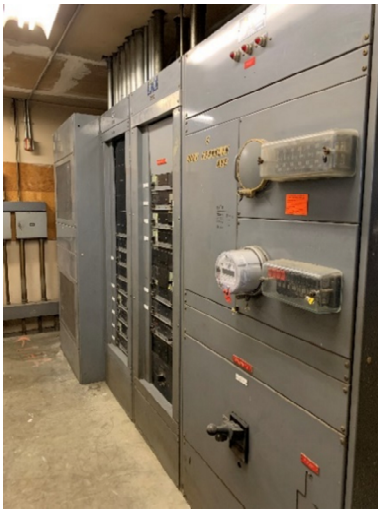
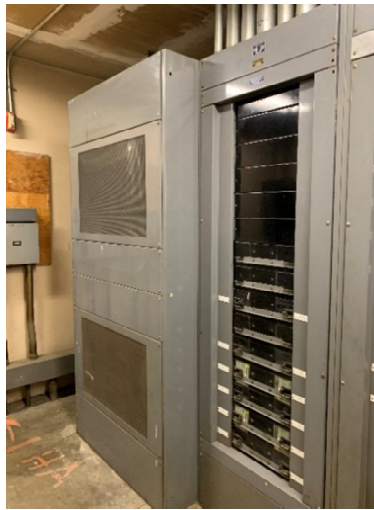
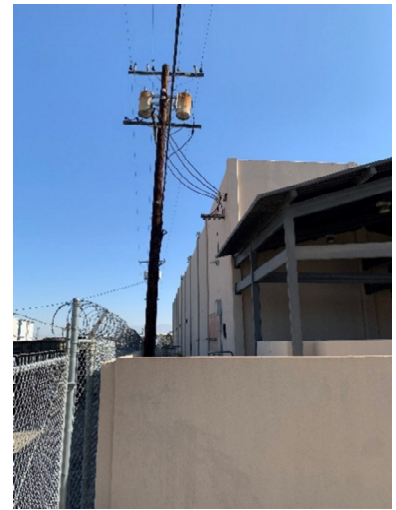
The existing main electrical service is rated 277/480V 3Phase 4W rated at 1200Amps. The switchgear is aged and looks to be original to the building. The switchgear has exceed its life expectancy and should be considered for replacement. The switchboard has a large transformer that is currently buss tapped by manufacturer in order to provide 120/208V 3P 4W power to the building. The size of the transformer is unknown as there is no label attached to it. The electrical room is completely full with no more room to add panels in the same area. This could be a concern as time goes by and equipment starts to get added to the system. The electrical service is fed by pole mounted utility transformers that are also aged and should be replaced by the utility company when the building is occupied.

Main Switchboard

Transformer attached to Switchgear

Utility Transformers on Pole

It is recommended that the main electrical switchboard and any transformer and panelboard older than 15 years be replaced. The main switchboard is not in ideal condition to be reconditioned and with older style circuit breakers you cannot get any new ones. Ideally the electrical room would need to be re-designed in order to properly fit and install all the required switchgear for its currently condition and future use. Currently the electrical room meets minimum requirements for the installation of the switchgear, but adding any future panels is not possible. Would also advise to do some circuit tracing and verify all the loads coming off from each panel is accurate. New accurate panel schedules would be provided for each panelboard so that it makes it easier for maintenance to shut loads off.

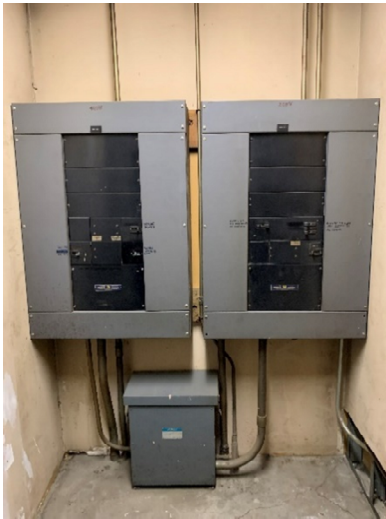
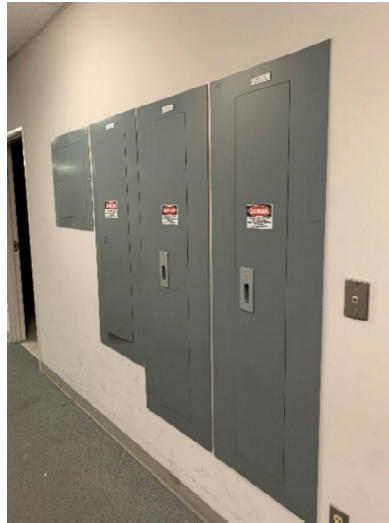
The remainder of the building has multiple panels installed. The same issues are presented as the switchgear. Some of the panels are old and need replacement, while other are newer and can be reused. Most panels are completely full with some panels having very limited spaces available for expansion. Circuit breakers for the older panels are not easy to come by and replacement circuit breakers have been installed that do not match the panel. Although this is not a code violation, the circuit breakers don't quite fit in the spaces allocated for the circuit breakers. There are also some load centers located within the building. Load centers are cheaper residential style forms of panelboards. These do not hold up very well in commercial areas and tend to have issues. Although they are not old, they should be replaced with commercial style panelboards.

Older Panelboards and Xfmr

Newer Panelboards

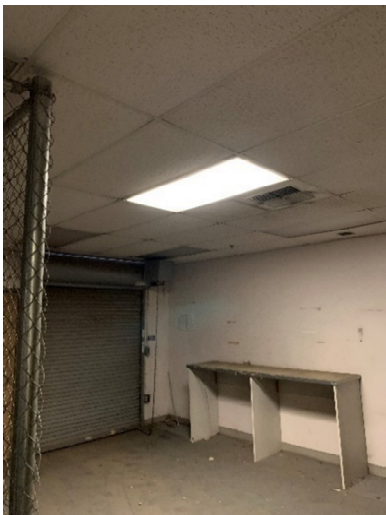
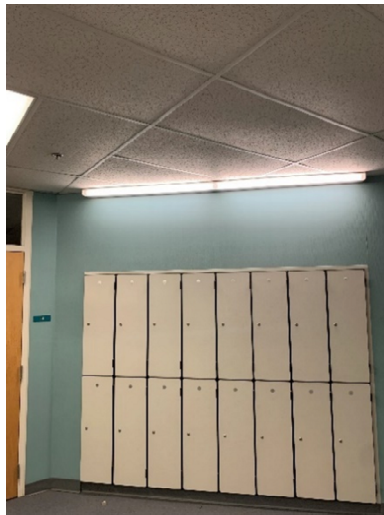
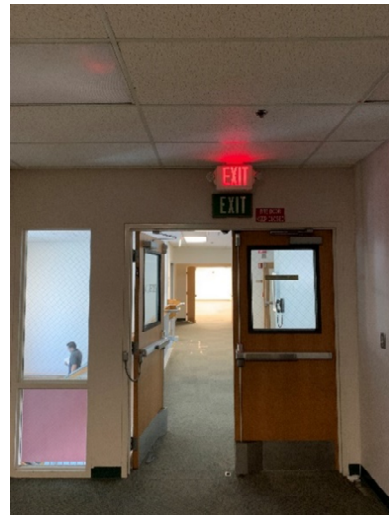
The building is fed out of common panels in the hallways and electrical rooms. The existing lighting fixtures are mainly ceiling recessed fixtures with fluorescent lamps, with a mixture of some surface mounted fluorescent fixtures. Although the lighting is not original to building, they are still at least a generation old and should be replaced. Emergency lighting is fed from multiple sources such as internal battery backup and emergency only fixtures (bugeyes). These systems seem to be in compliance for the most part, but the fixtures are aged and should be replaced. Exit signs for the most part are in correct locations but some do not work, and others are showing their age and should be replaced.

Typical lighting

Typical lighting in Corridors

Typical Exit Sign and Emergency Light

The existing lighting should be replaced with new energy efficient LED fixtures. All new fixtures would greatly increase the quality of lighting and also reduce the energy consumption by approx. 30%. By replacing the fixtures, the facility will need to comply with current 2016 California Energy Code requirements. This would mean that all spaces would need dimming and auto shutoff. This can be easily accomplished by replacing all the existing wall switches with a combination occupancy sensor/dimming switch. Any space that does not require dimming would just have an occupancy sensor. By adding the sensors and dimming options, this would also decrease the energy consumption significantly. Also, certain spaces would require day-light control, these spaces will need further controls to meet current requirements. Controls can be accomplished with stand alone systems or in some cases the controls can be installed within the fixtures to minimize additional systems.

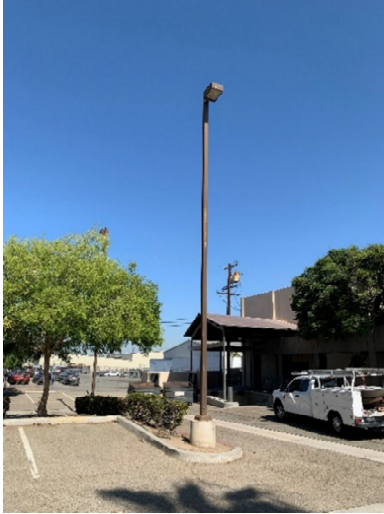
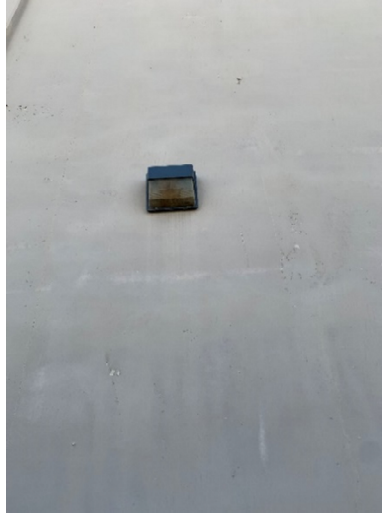
The existing site lighting parking lot fixtures are pole mounted with HID style lamps. These fixtures appear to be original to the building and should be replaced. Building lights are also HID style fixtures and are severely aged. These fixtures will need to be replaced and some appear not be in working condition. Existing lighting controls are not T24 compliant and need to be replaced.

Typical light fixture in Parking Area

Typical light fixture on Building

It is also recommended that all site lighting be replaced, this includes the parking lot and building lights. New fixtures should be LED energy efficient type. Exterior fixtures mounted under 24' shall have integral occupancy sensors per T24 requirements. New lighting controls for overall control of exterior fixtures will also need to be installed.

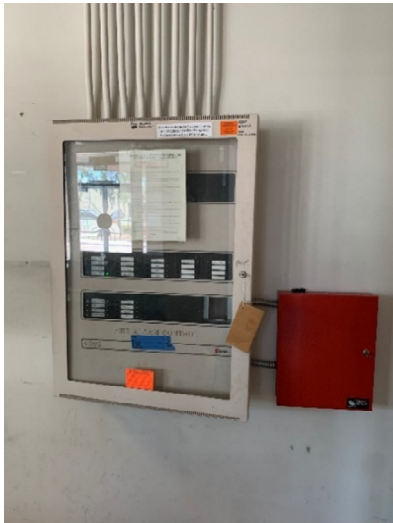
The existing fire alarm system is old and looks to be original to the building. Over the years it appears that the main control panel has been modified to meet current standards but upgrades are no longer feasible and should be replaced. Some of the fire alarm devices are newer than others and could possibly be reused with a new system, but in general the entire system should be replaced.

Existing Main Fire Alarm Panel

It is recommended that a new addressable fire alarm system with full voice evacuation replace the existing obsolete system. Audible and visual notification to meet all current California Fire Code and NFPA 72 intelligibility requirements. New system shall be California State Fire Marshall approved and shall work in conjunction with the elevator controller for all required elevator recall functions.

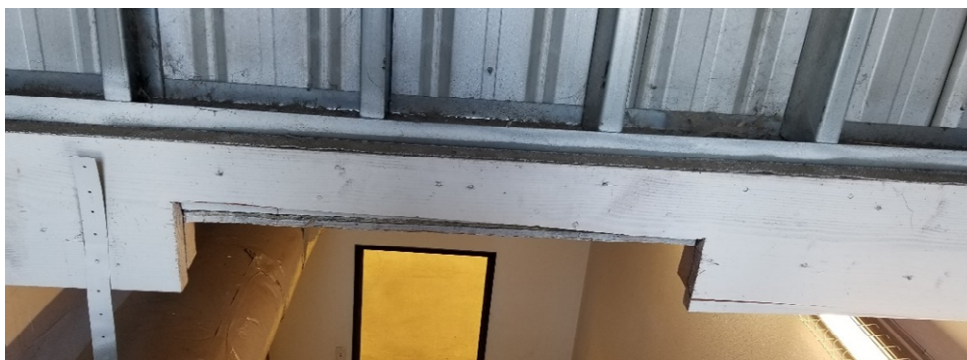
First, a beam section by the roof access entry was partially cut, most likely for head room clearance. Please refer to *Figure 7* for observation. Further analysis needs to be performed to determine if the reduced section is acceptable. The beam may need to be strengthened or replaced. The roof and second floor framing were only observed at a few locations and at the locations that were observed, no other damage to the joist and beams was visible.

Figure 7: Cut out beam section

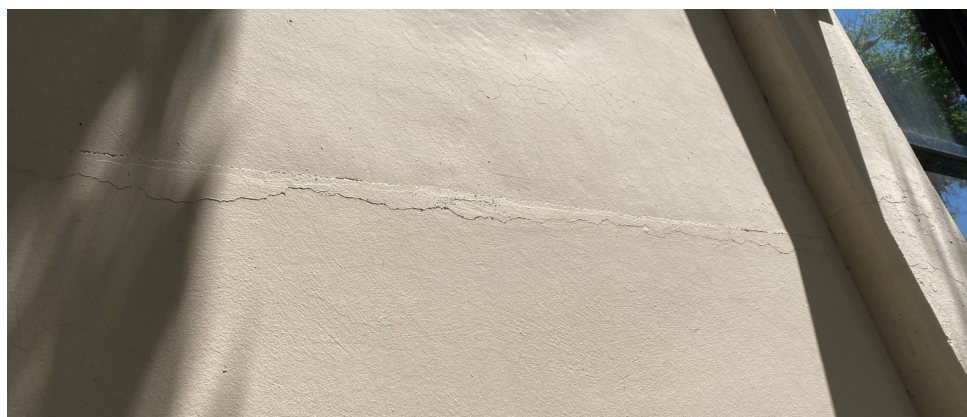
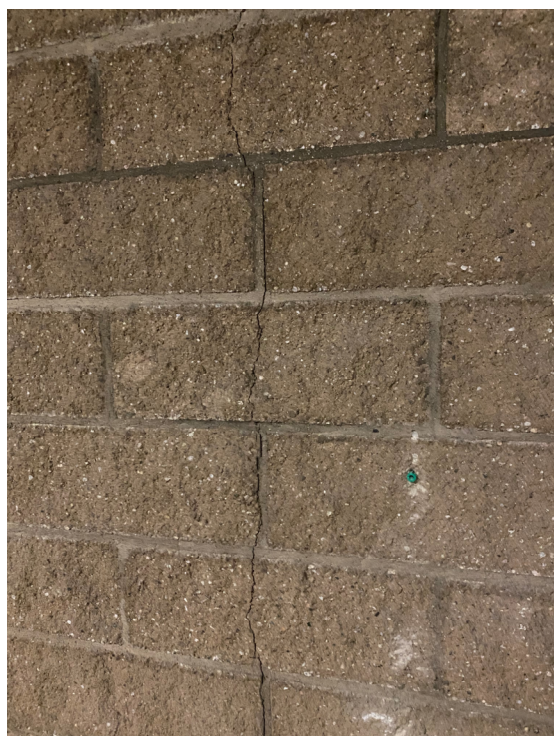
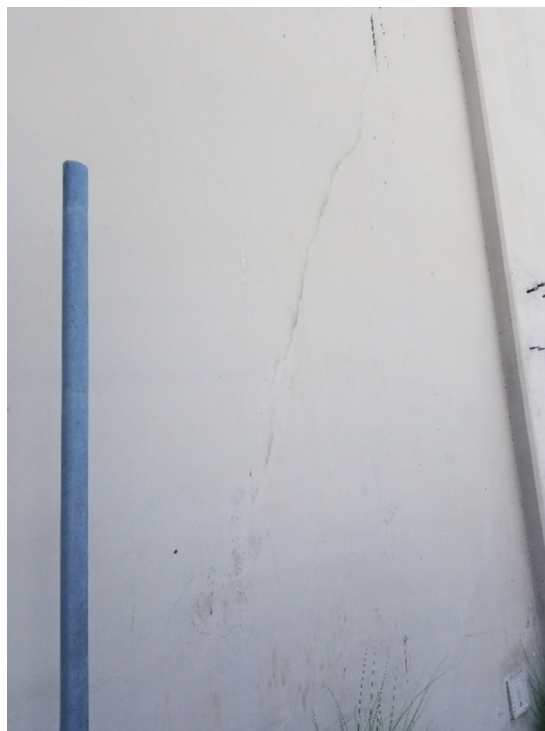
Secondly, there are some cracks in the masonry and concrete walls. The cracks vary in length but all of them appear to be less than 1/8 inch wide. Please refer to *Figure 8-10* for observation. The cracks are likely due to material shrinkage and/or temperature changes. The cracks do reduce some of the capacity in the lateral force resisting system and gravity system however from visual inspection we believe there is enough redundancy in the number of walls that the structural system is still structurally adequate. Structural repair to the exterior concrete and masonry walls is not required at this time.

Figure 8: Crack on the exterior concrete wall

Figures 9&10: Cracks on the masonry and concrete wall
